# Manhole Inspection Summary

Manhole # S17A\_\_013MH

Insp Date: **11/27/07 10:27 AM**

**Location** Address: **REAR 2327 HARLEM**

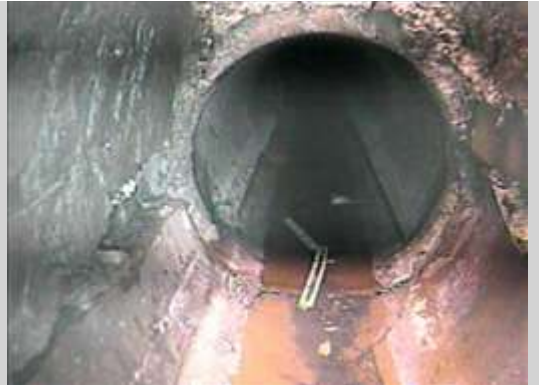
12 O'Clock Outflow

10 in. Circular Gravity Sewer  
Pipe Out @ 12 O'Clock

Pipe Height: (in.) Direct  
Pipe Material: **Clay** ☐ Pipe Lined  
Invert Depth: **8.02** (ft.) Flow Characteristics: **Slow**  
Deposits: ☒ None ☐ Mud ☐ Sludge ☐ Debris ☐ Grease  
Silt Depth: (in.) Deposits Extent:  
Infiltration: **None** Pipe Seal Cond: **Sound**

Connects To: **Manhole**

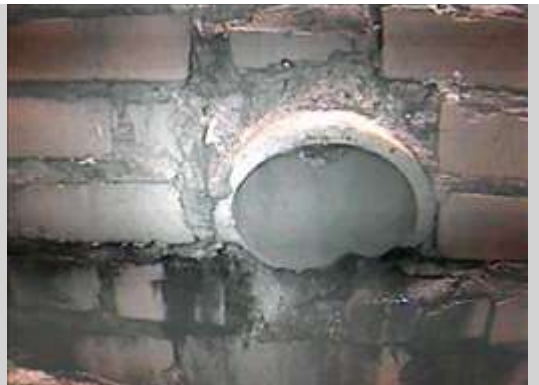
3 O'Clock Inflow

6 in. Circular Gravity Sewer  
Pipe In @ 3 O'Clock

Pipe Height: (in.) Direct  
Pipe Material: **Clay** ☐ Pipe Lined  
Invert Depth: **6.05** (ft.) Flow Characteristics: **Slow**  
Deposits: ☒ None ☐ Mud ☐ Sludge ☐ Debris ☐ Grease  
Silt Depth: (in.) Deposits Extent:  
Infiltration: **None** Pipe Seal Cond: **Sound**

Connects To: **House connection / Service line**

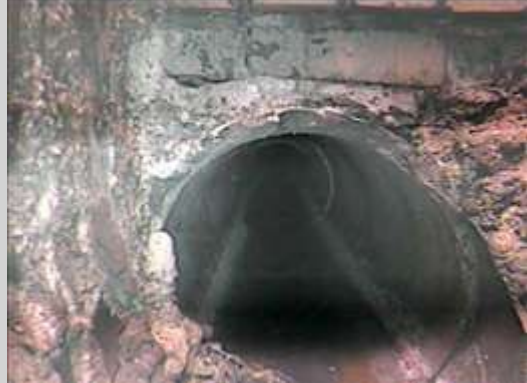
6 O'Clock Inflow

10 in. Circular Gravity Sewer

Pipe In @ 6 O'Clock

Invert Depth: **7.98** (ft.) Flow Characteristics: **Slow**

Infiltration: **None** Pipe Seal Cond: **Sound**

Connects To: **Stub connection / abandoned**

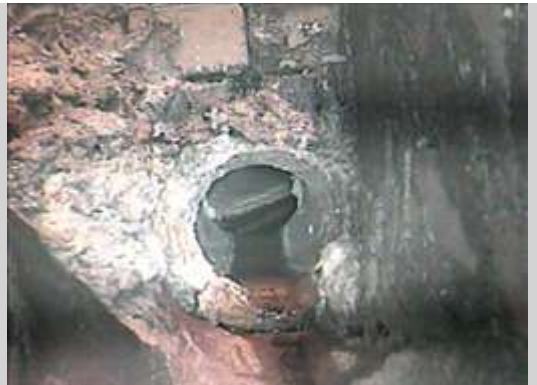
7 O'Clock Inflow

4 in. Circular Gravity Sewer

Pipe In @ 7 O'Clock

Invert Depth: **7.66** (ft.) Flow Characteristics: **Slow**

Deposits: ☐ None ☐ Mud ☒ ~~Sludge~~ ☐ Debris ☒ Grease

Silt Depth: **0.5** (in.) Deposits Extent: **Light**

Infiltration: **None** Pipe Seal Cond: **Sound**

Connects To: **House connection / Service line**
